LEAD CONTAMINATION FROM THE GOLDEN GATE BRIDGE REPAINTING PROJECT

Specifications to Prevent Contamination Repeatedly Violated

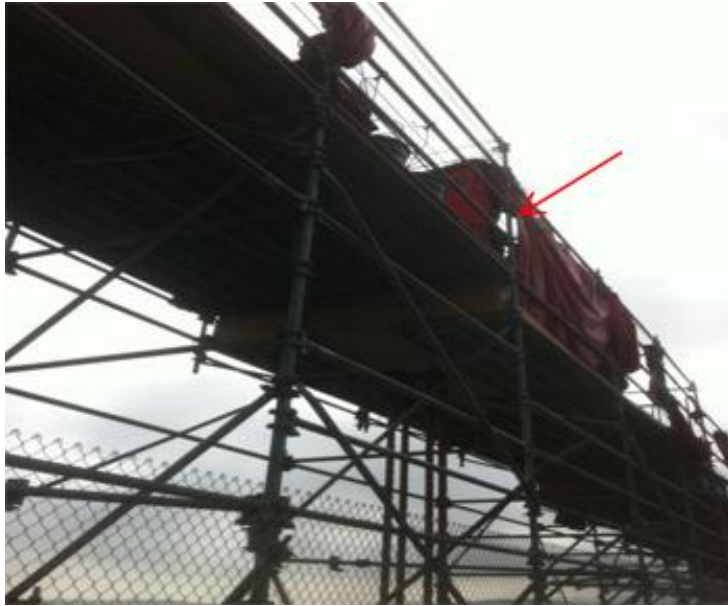
Fig. 1: Picture taken of “containment structure” at east side of Bridge. At the arrow you can see the sky through the structure where a roof should be blocking this view. Curtains are not fastened together resulting in large gaps.

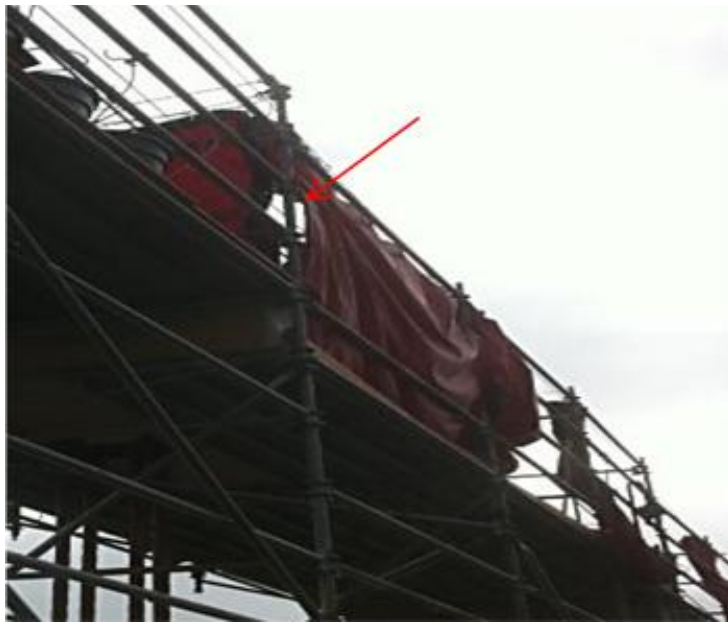
Fig. 2: Close-up of containment structure with arrow at gap.

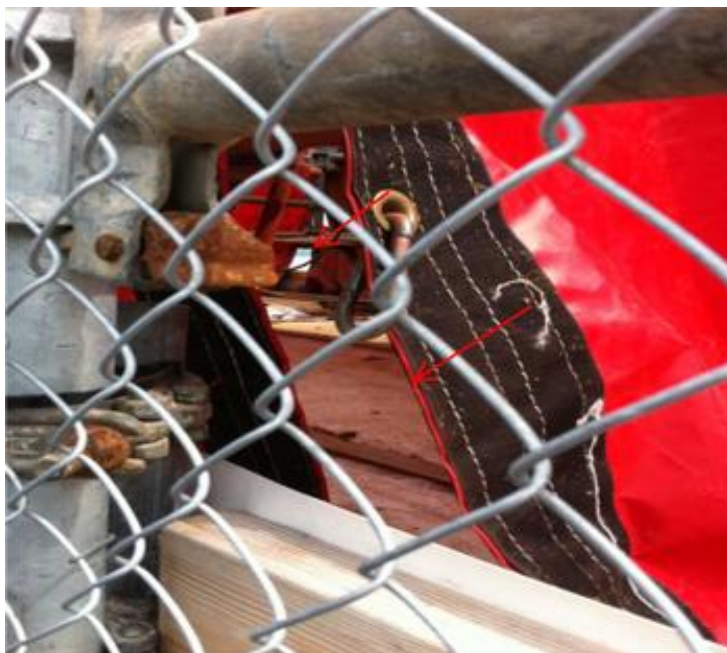
Fig. 3: A close-up view of a large gap in a “containment structure” where power tools are being used to remove lead-bearing materials during the MCRRP.

In our own monitoring we have been on the Bridge and witnessed paint chips being blown out of the containment structure into the environment including onto the public walkway below. We have collected these paint chips which tested hot for lead right there on the spot. It is clear these contaminants are not just being blown onto the public walkway, but they are also being blown into the Bay and adjacent lands.

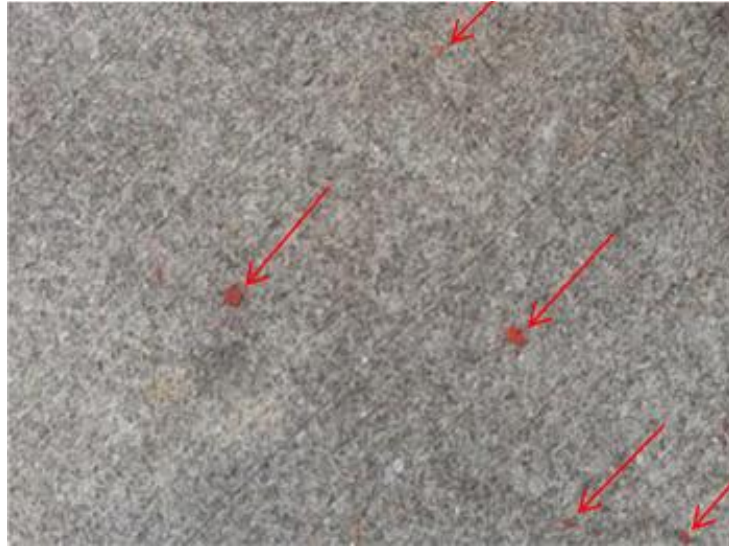
Figure 4 below is a photograph showing lead-bearing paint chips found on the public walkway below the lead containment structure. Paint chips such as these often remain on the public walkway long after the Bridge painters go home for the day.

Fig. 4: Photograph of lead-bearing paint chips on the public sidewalk on the east side of the Bridge under lead containment structure.

These issues are also addressed in a December 2011 report from Vantagepoint Consulting, the firm hired by the District to act as a consultant on the MCRRP project. In their report, Vantagepoint states that “some visible paint debris was observed on the sidewalk below the work areas which locations should be policed on a daily basis and any residues removed.”³ Despite Bridge management being given this reminder by its own paid consultant, Bridge painters subsequently still left work for the day without removing lead residue that escaped their “containment structure” and fell down on the public walkway or elsewhere.
